**DEPARTMENT OF TRANSPORTATION**

Contract #: 04-0120F4Cty: SF/ALA Rte: 80 PM: 13.2/13.9File #: xx.28**WELDING INSPECTION REPORT****Resident Engineer:** Siegenthaler, Peter**Address:** 333 Burma Road**City:** Oakland, CA 94607**Report No:** WIR-021477**Date Inspected:** 02-Mar-2011**Project Name:** SAS Superstructure**OSM Arrival Time:** 700**Prime Contractor:** American Bridge/Fluor Enterprises, a JV**OSM Departure Time:** 1900**Contractor:** Zhenhua Port Machinery Company, Ltd (ZPMC), Changxing Island **Location:** Shanghai China**CWI Name:** Mr. Zhu Zhong Hai.**CWI Present:** Yes No**Inspected CWI report:** Yes No N/A**Rod Oven in Use:** Yes No N/A**Electrode to specification:** Yes No N/A**Weld Procedures Followed:** Yes No N/A**Qualified Welders:** Yes No N/A**Verified Joint Fit-up:** Yes No N/A**Approved Drawings:** Yes No N/A**Approved WPS:** Yes No N/A**Delayed / Cancelled:** Yes No N/A**Bridge No:** 34-0006**Component:** OBG Trial Assembly**Summary of Items Observed:**

## WELDING INSPECTION REPORT

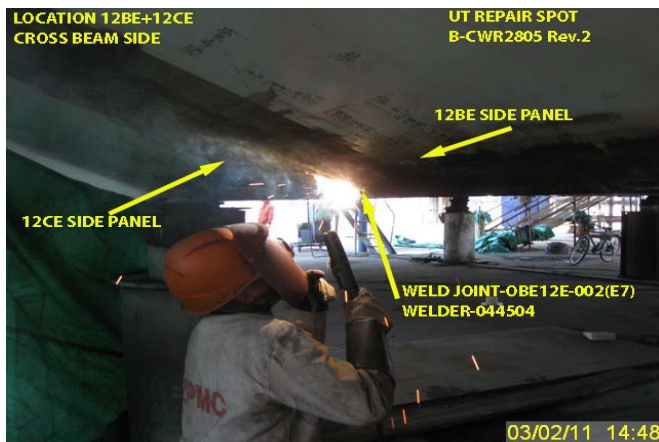
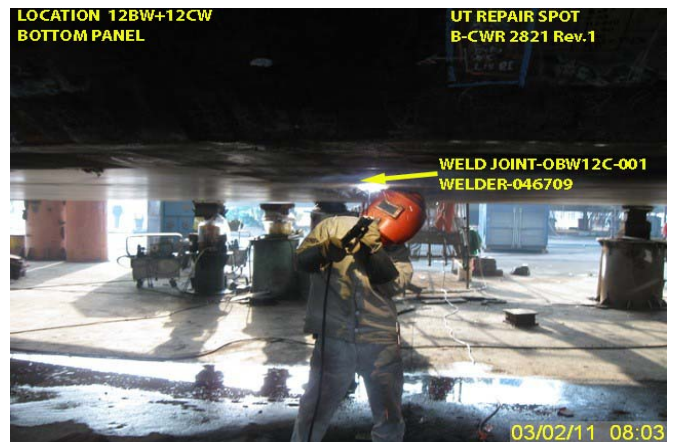
SMAW welding of Weld Joint DP3018-001-022(12BE+12CE,DP-LD,BK Side), and Welding Repair Report(WR)B-WR20290, Welder is identified as 044504; ZPMC Quality Control (QC) is identified as Mr. Wang Li Yang. The welding variables appeared to comply with the Applicable WPS-345-SMAW-4G(4F)-FCM-Repair-1.

SMAW welding of Weld Joint FB3050-017-007(CB17 Side plate to Stiffener), And Welder is identified as 040270; ZPMC Quality Control (QC) is identified as Mr. Li Yang . The welding variables appeared to comply with the Applicable WPS-B-P-2114-FCM-1.

SMAW welding of Weld Joint FB3054-001-020(12AW+CB17,Side plate to I Stiffener,PP110), And Welder is identified as 040270; ZPMC Quality Control (QC) is identified as Mr. Li Yang. The welding variables appeared to comply with the Applicable WPS-B-P-2114-FCM-1.

SMAW welding of Weld Joint OBE12E-002 (12BE+12CE,SP-SP,CB Side), and Critical Welding Repair Report(CWR)B-CWR2805 Rev.2, Welder is identified as 044504; ZPMC Quality Control (QC) is identified as Mr. Wang Li Yang. The welding variables appeared to comply with the Applicable WPS-345-SMAW-4G(4F)-FCM-Repair-1.

SMAW welding of Weld Joint SEG3004AG-048 (12AW Partial Diaphragm PP110), And Welder is identified as 057333; ZPMC Quality Control (QC) is identified as Mr. Li Yang. The welding variables appeared to comply with the Applicable WPS-B-P-2213-B-U2-FCM-1.

SMAW welding of Weld Joint OBW12C-001 (12BW+12CW,BP-BP), and Critical Welding Repair Report(CWR)B-CWR2821 Rev.1, Welder is identified as 046709; ZPMC Quality Control (QC) is identified as Mr. Wang Li Yang. The welding variables appeared to comply with the Applicable WPS-345-SMAW-4G(4F)-FCM-Repair-1.

SMAW welding of Weld Joint SEG3006A-012(12BW+12CW,BP-SP,CW Side), and Welding Repair Report(WR)B-WR20317, Welder is identified as 046709; ZPMC Quality Control (QC) is identified as Mr. Wang Li Yang. The welding variables appeared to comply with the Applicable WPS-345-SMAW-1G(1F)-FCM-Repair-1.

Unless otherwise noted, all work observed on this date appeared to be in general compliance with the applicable contract documents.
